***Revised Remedial Action Work Plan To Address PCB-Impacted Soils (Revision 1)**

Dutch Harbor Warehouse - WWII Building 551

EPA Site No. ANCSA00706; ADEC Site Hazard No. 27905; ADEC File No. 2542.38.036;
18 East Point Road, Amaknak Island, Unalaska, AK 99685

April 24, 2024

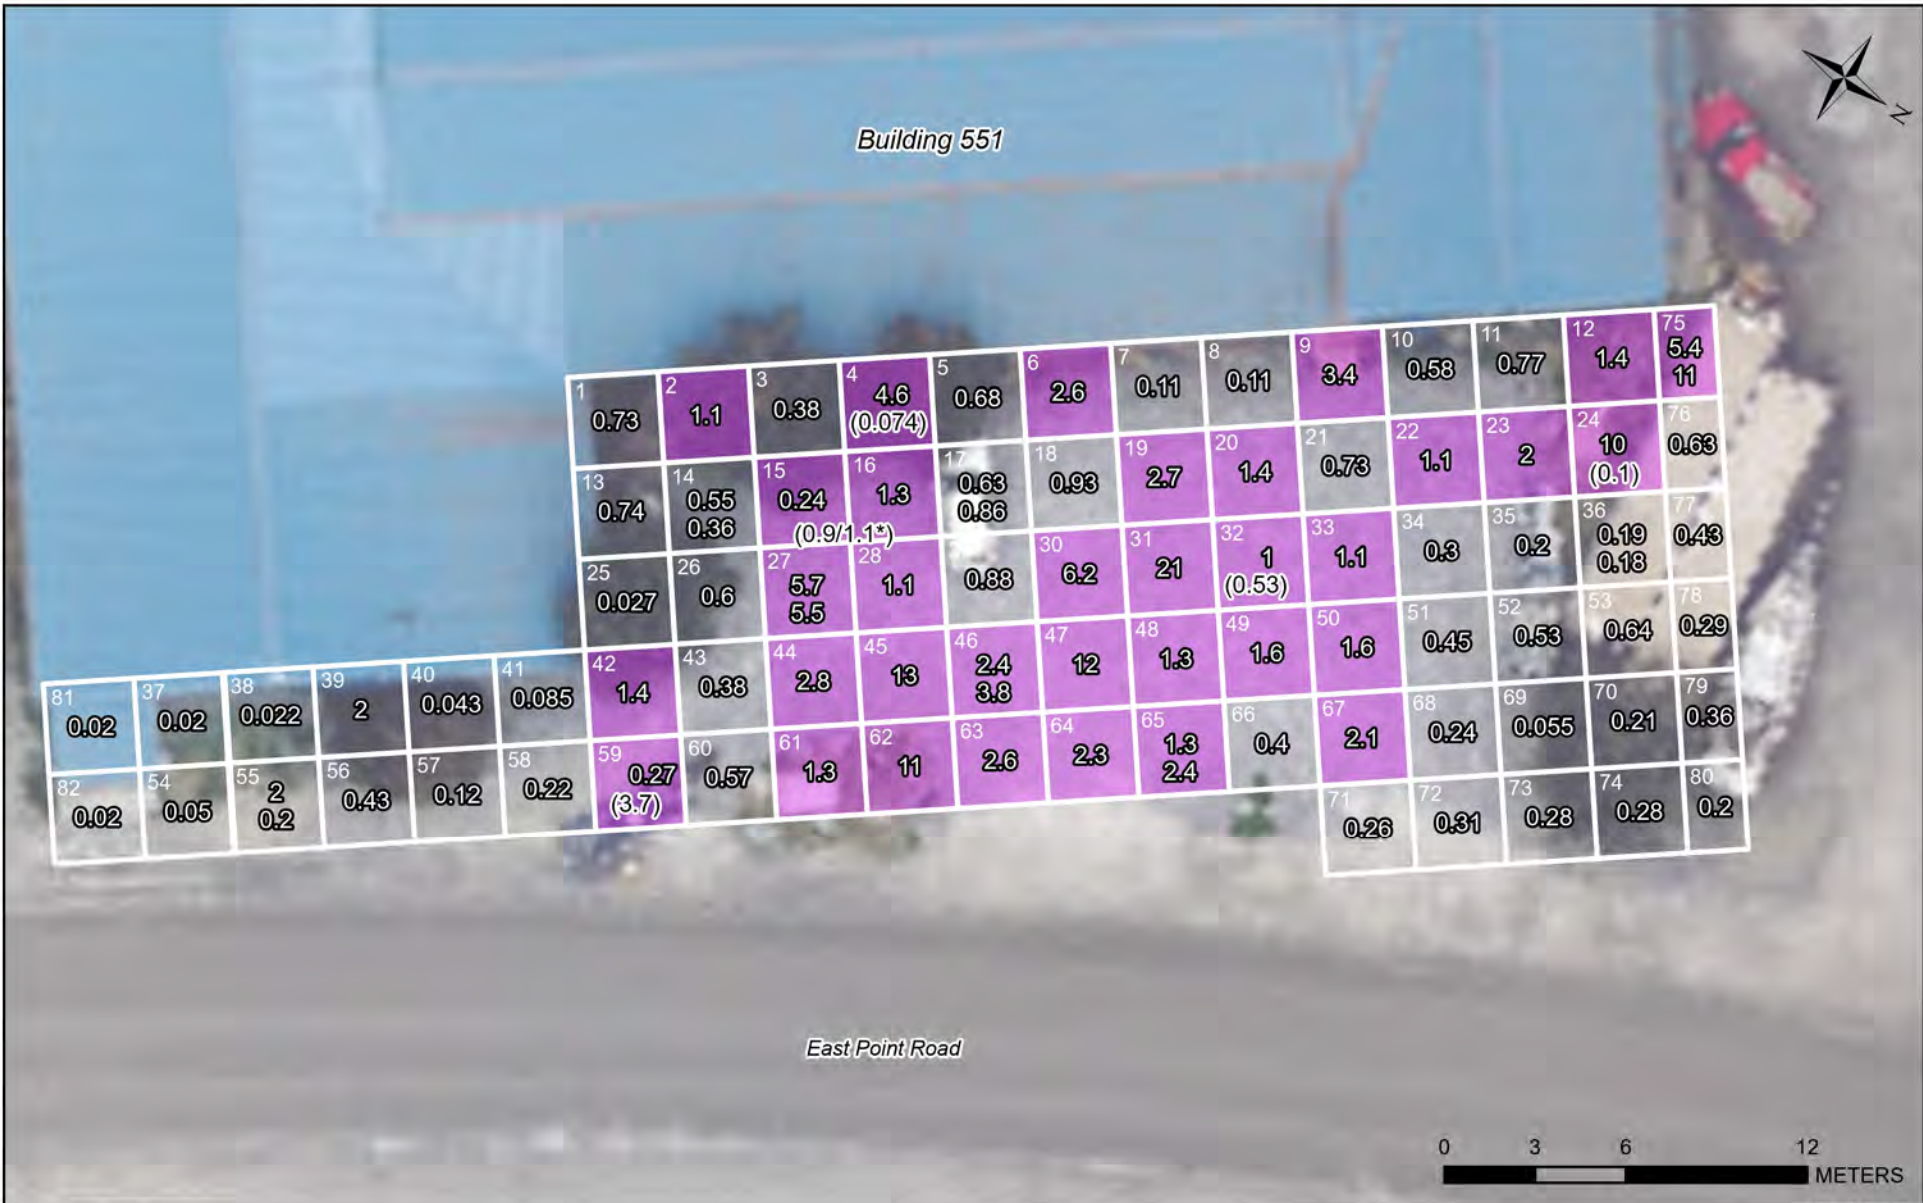
CREATION DATE: FEBRUARY 20, 2024	PROJECT NO: PROJ-0223536	FIGURE 4: SITE PLAN WITH DETAILED PCB RESULTS (FROM 2015 RAWP)
MONTROSE ENVIRONMENTAL	DRAWN BY: MNW APPRVD BY: KN	
	CHEK'D BY: KN REVISION: 1	BUILDING 551 DUTCH HARBOR, UNALASKA, ALASKA

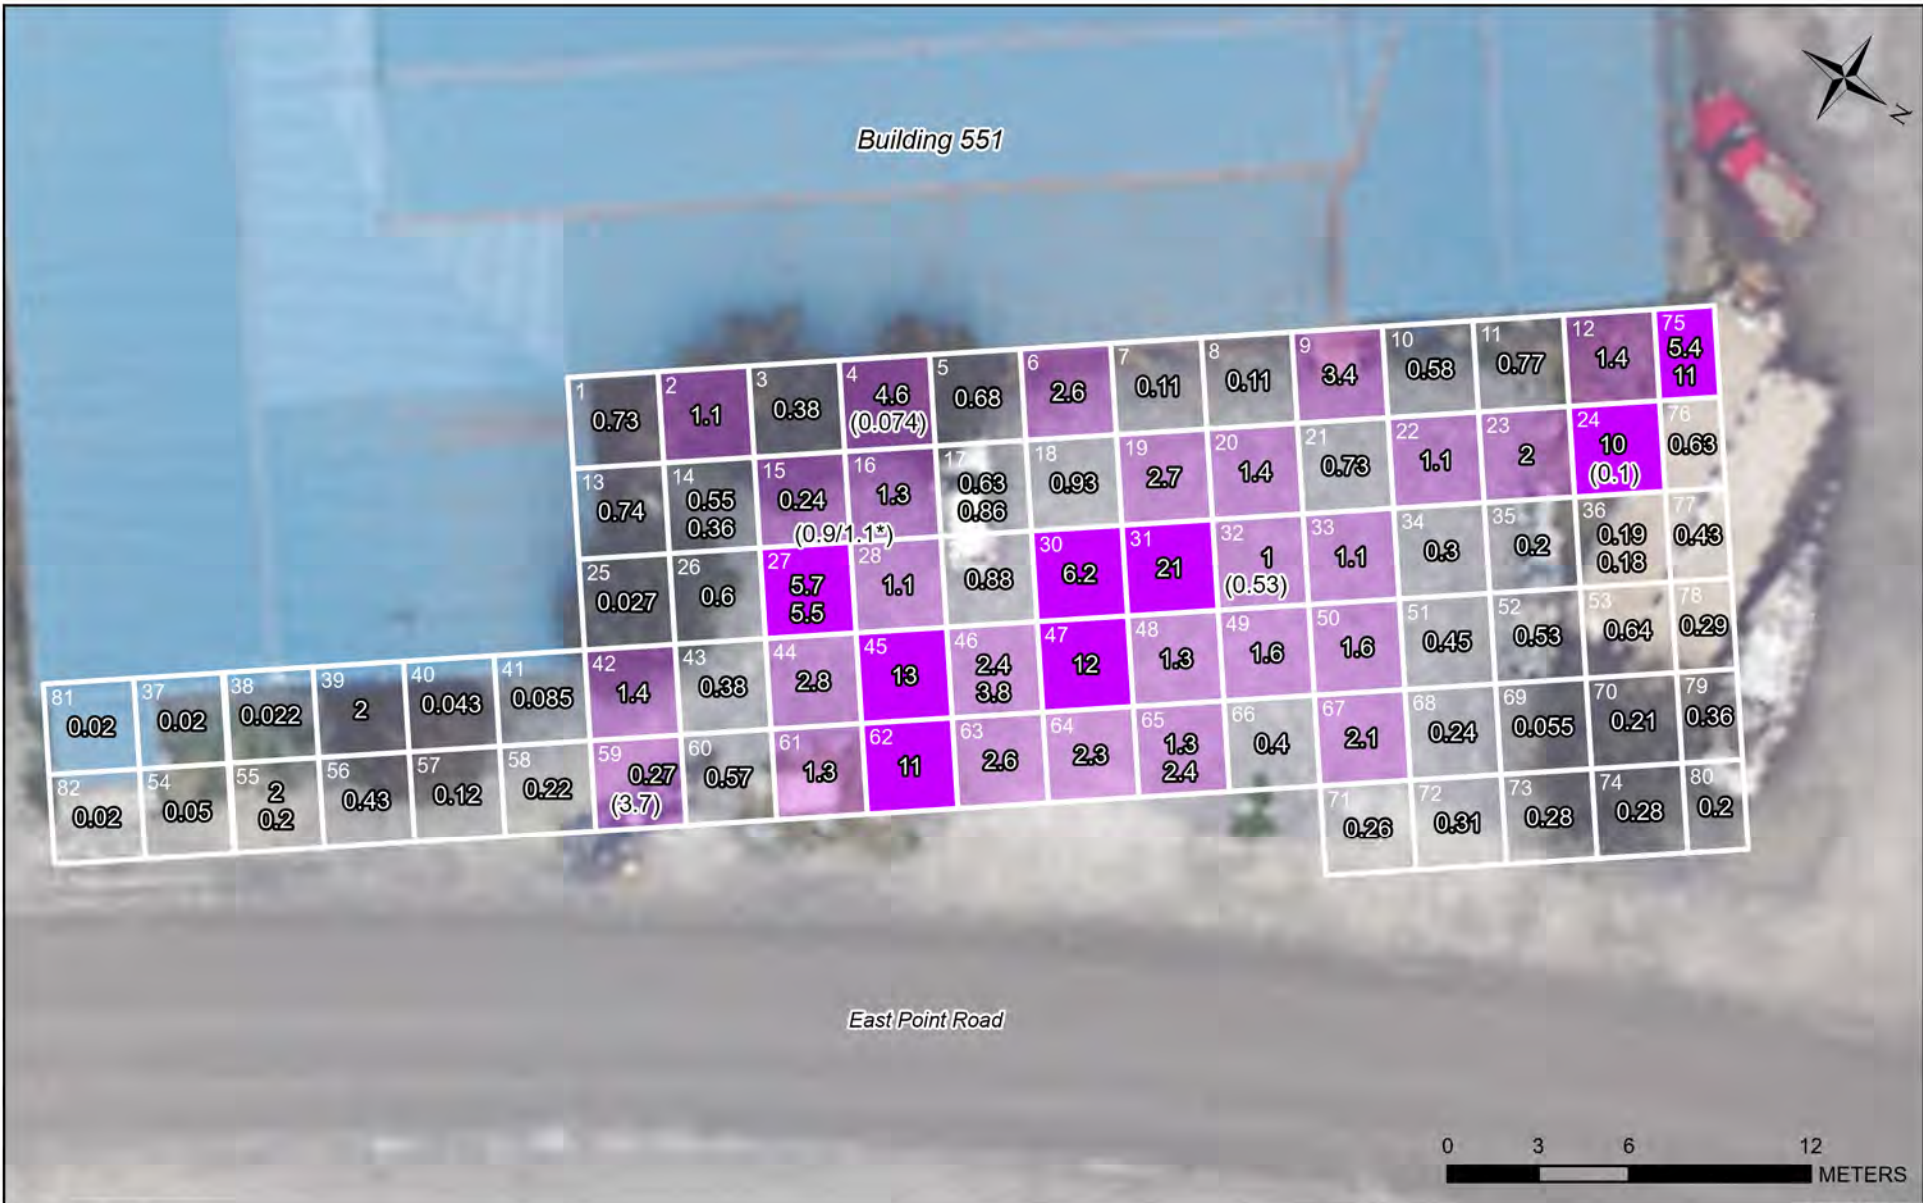
CREATION DATE: FEBRUARY 20, 2024	PROJECT NO: PROJ-0223536	FIGURE 5: SITE PLAN HIGHLIGHTING PCB RESULTS <5 MG/KG (FROM 2015 RAWP)
	DRAWN BY: MNW APPRVD BY: KN	
	CHEK'D BY: KN REVISION: 1	BUILDING 551 DUTCH HARBOR, UNALASKA, ALASKA

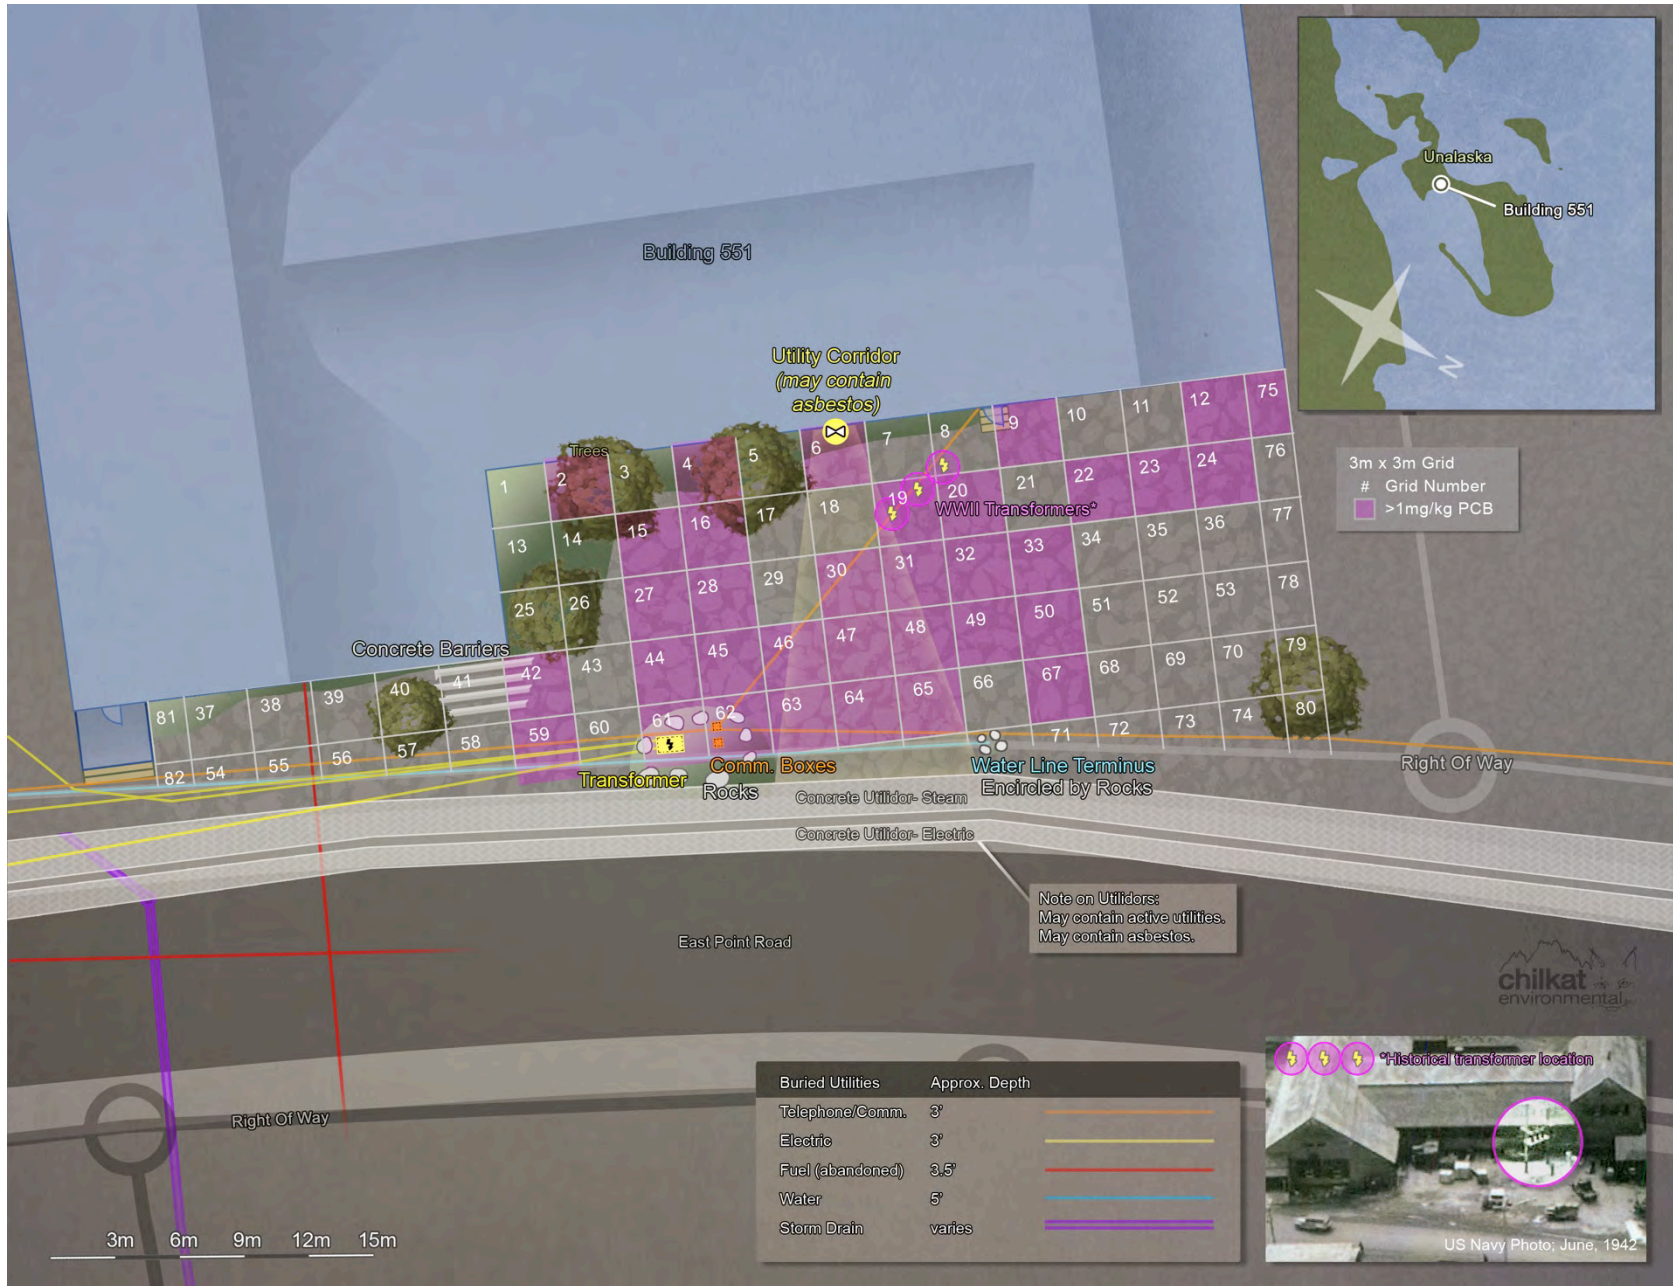
Figure 3: Grid layout with results above 1 mg/kg

Thirty-four of the eighty-two grids characterized were above 1 mg/kg. The contaminated soil lens is about one foot deep. For the purpose of volume estimation contaminated soil depth for surface samples is calculated at 1.5 feet. Grids are 3 meters square rendering about 5.4 yds³ each. The total volume of soil contaminated above 1 mg/kg was estimated at 180.9 yds³. However, cells with results below 1 mg/kg that are surrounded by cells over this level will require excavation to accomplish an excavation perimeter below 1 mg/kg. Accordingly, the total volume of contaminated soil is estimated at 280 yds³.

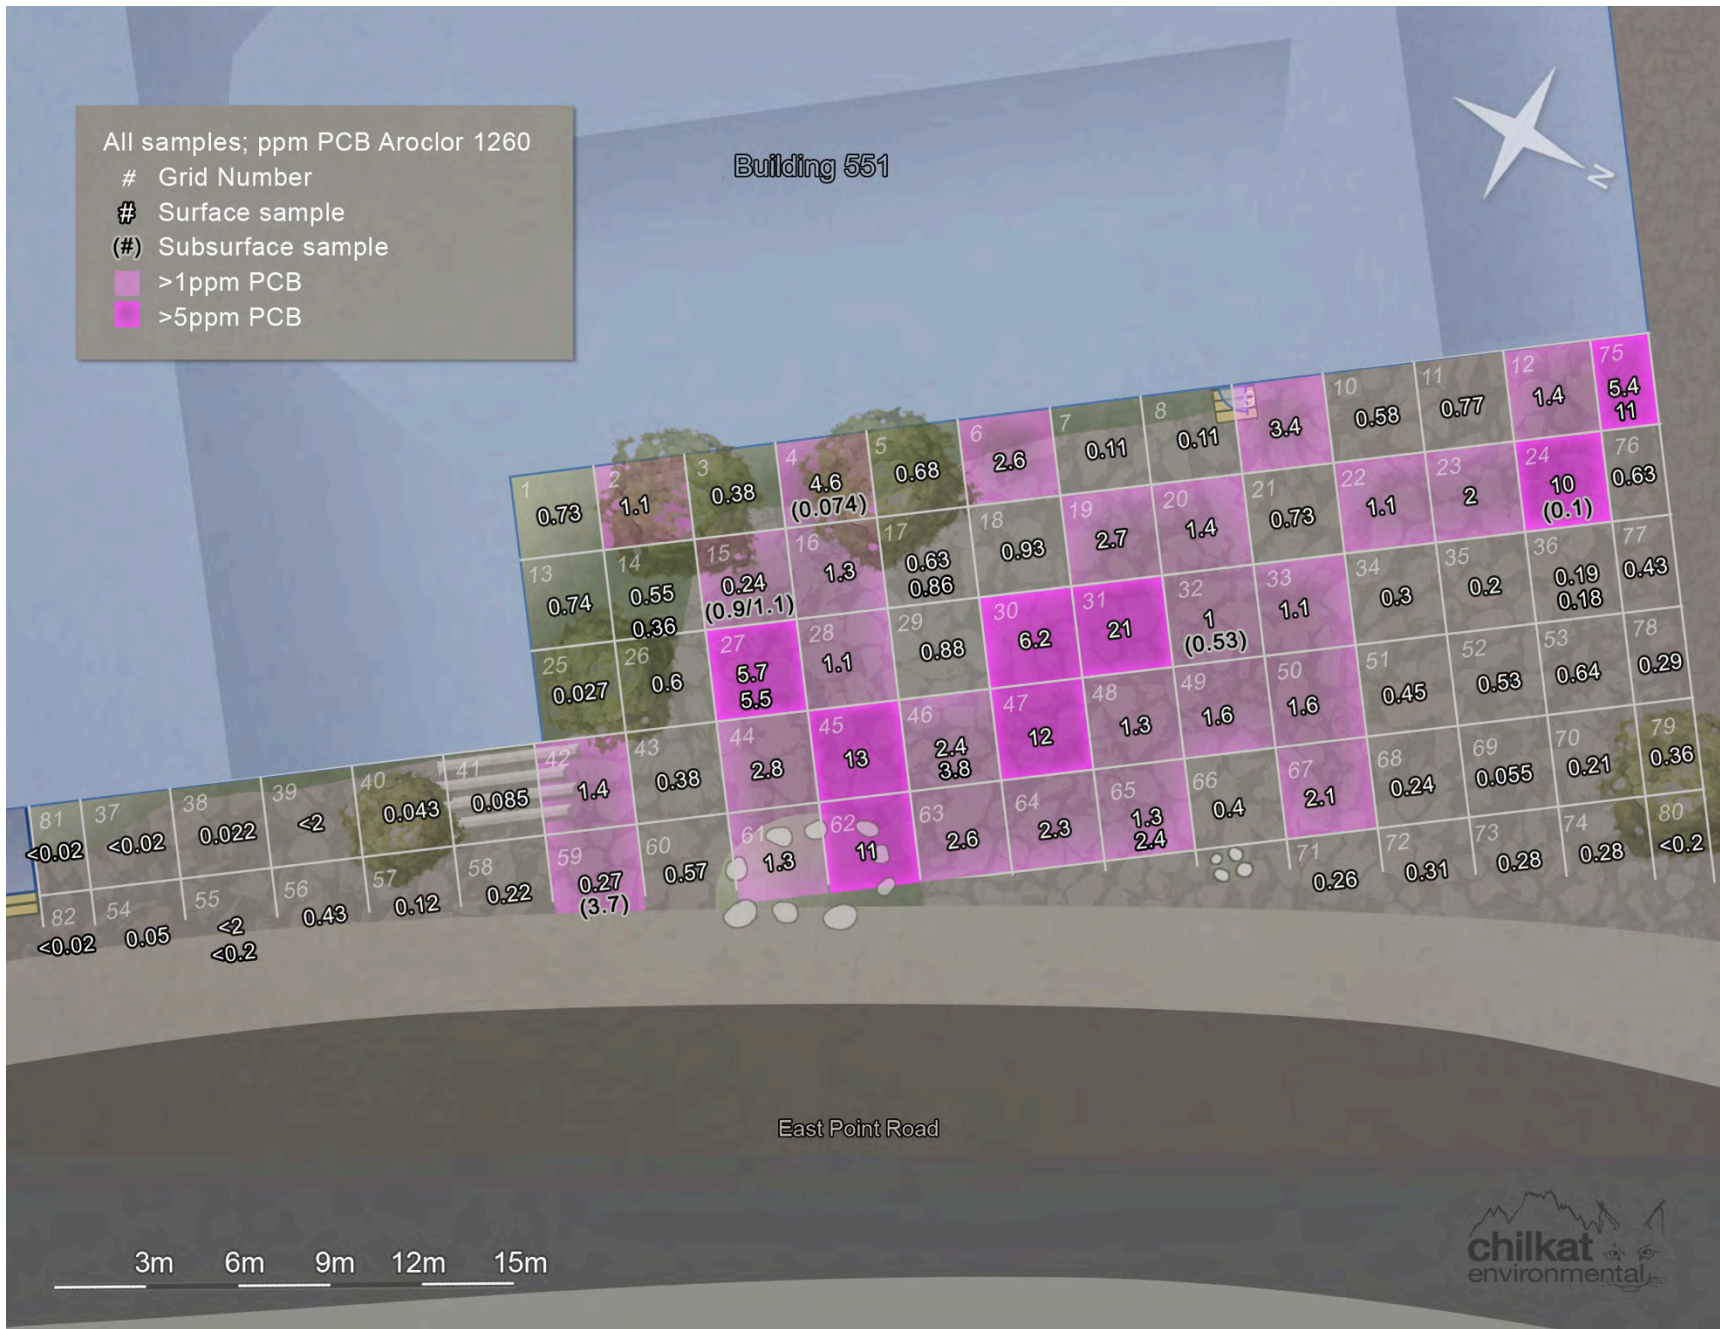
Figure 5: Grid layout with detailed results. Over 5 mg/kg highlighted to show hotspots.

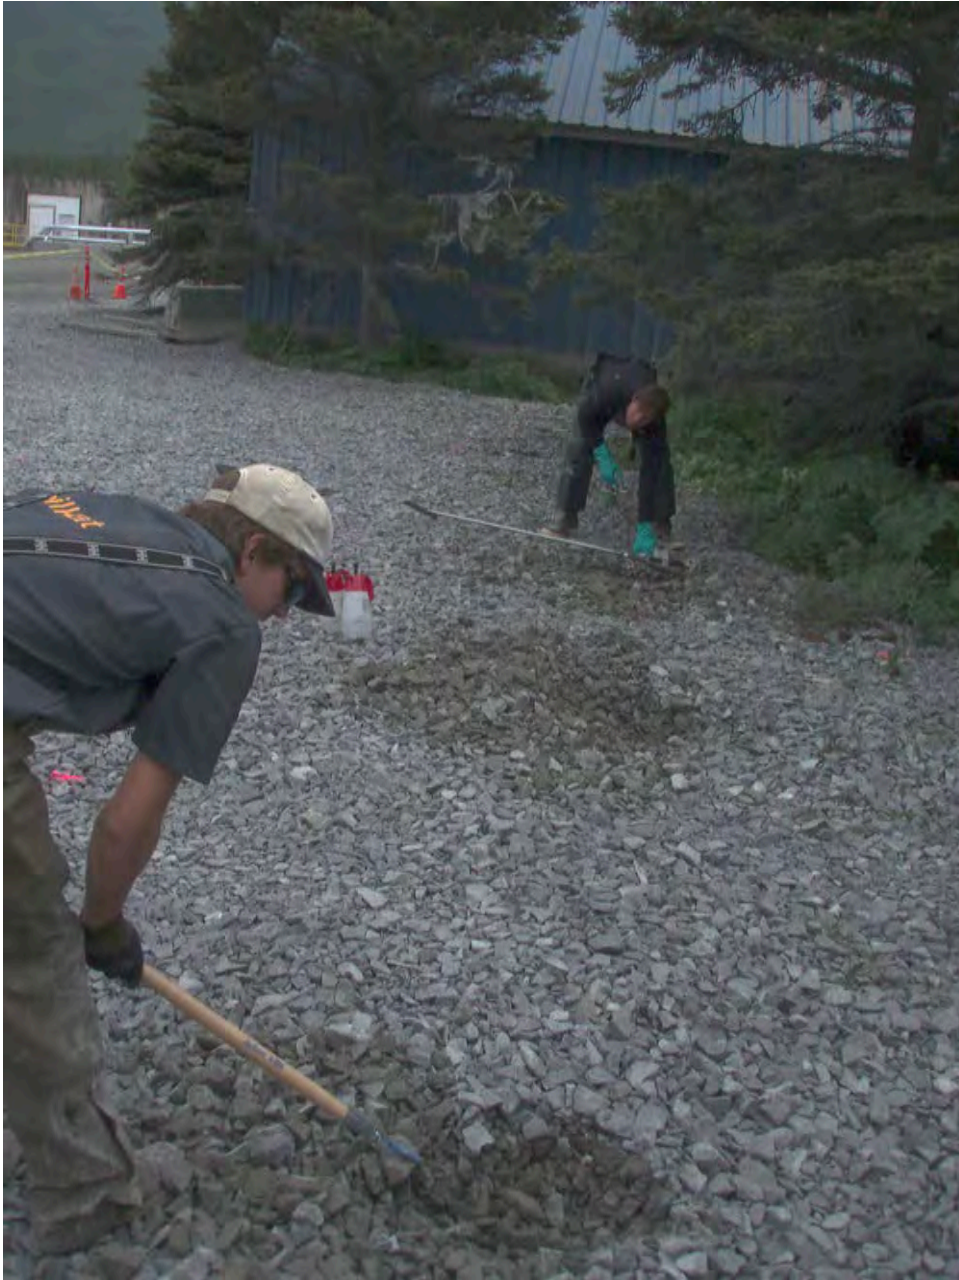
Photo 1: Clearing shot rock at sample locations

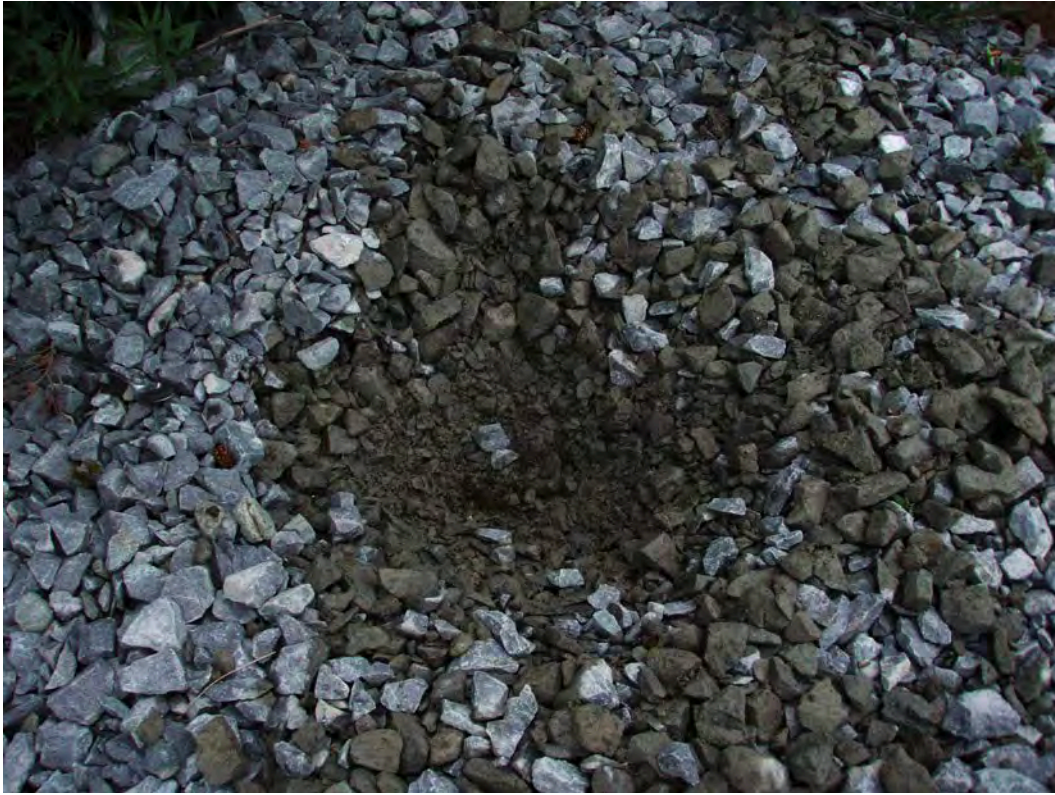
Photo 2: Expose fine grain soil without redistributing

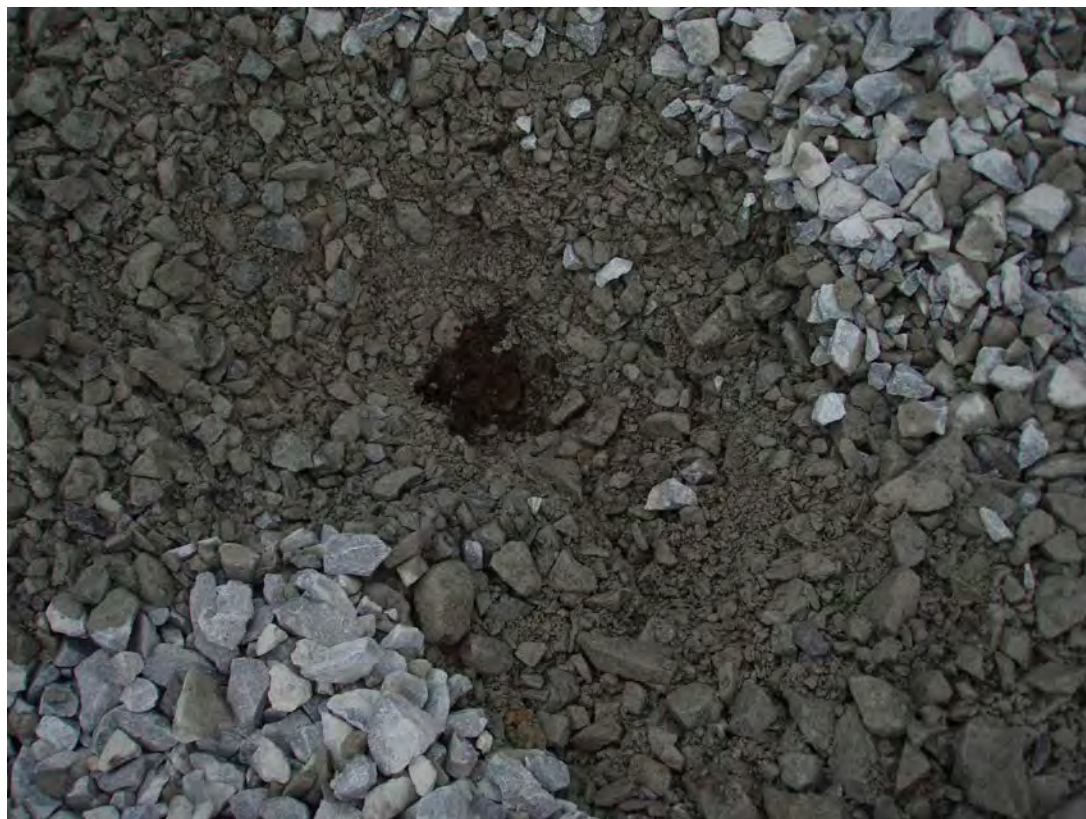
Photo 3: Further expose fine grain soil without redistributing

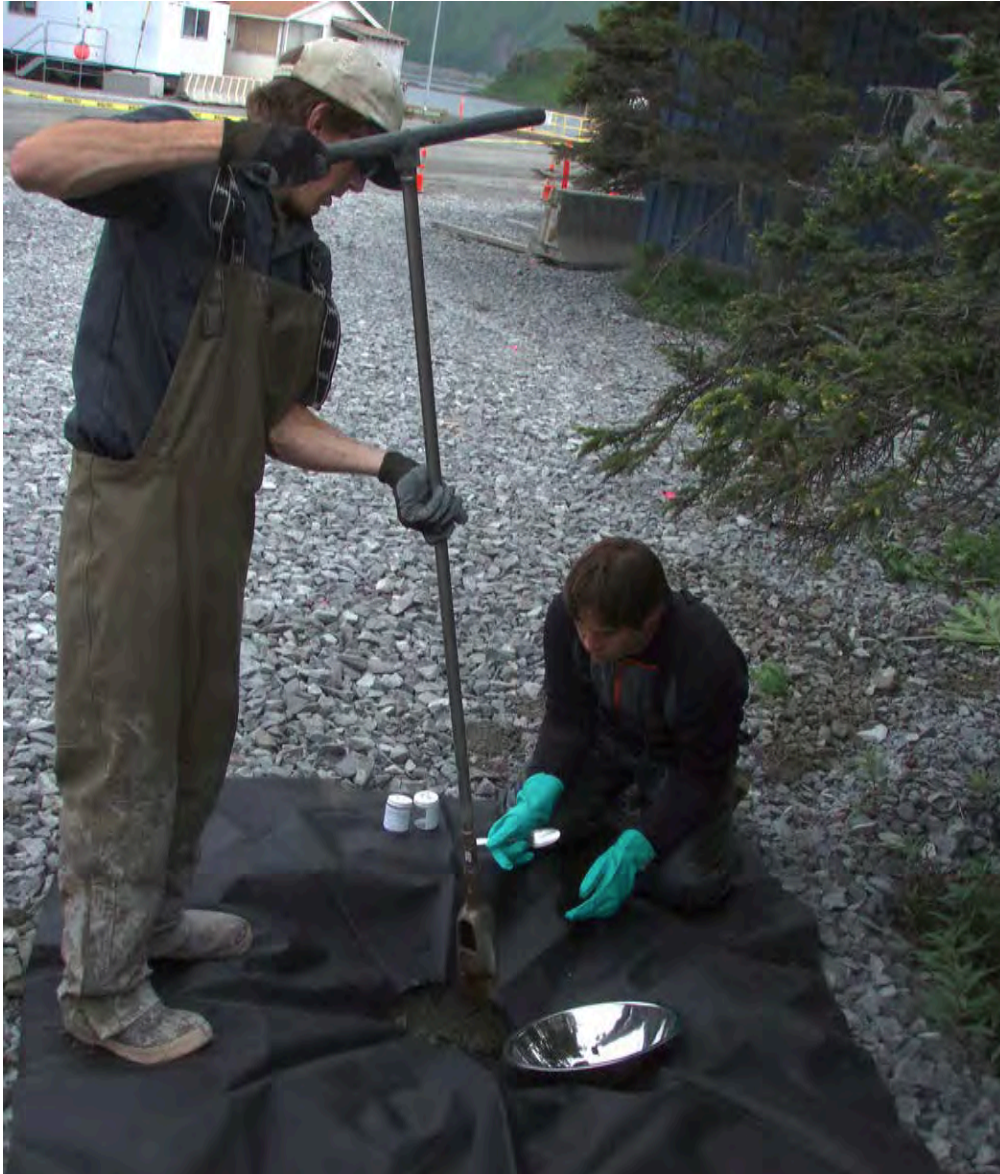
Photo 4: Auger into fine grain soil and store fines in stainless steel bowl.

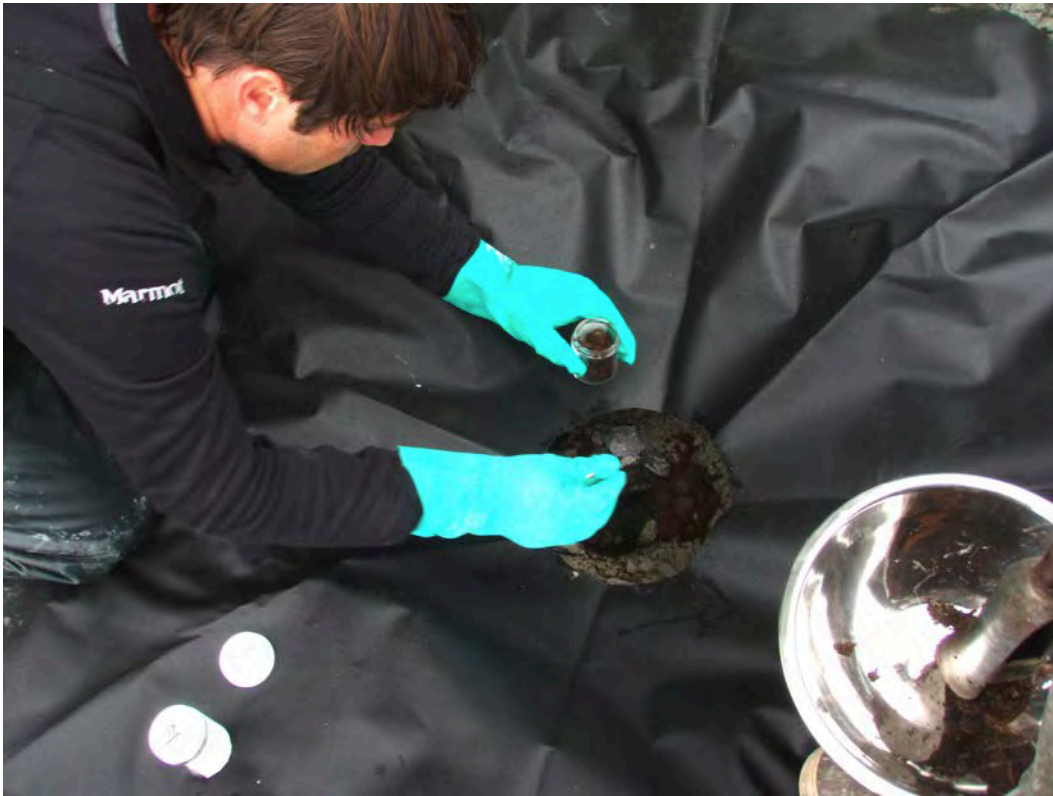
Photo 5: Sample fine grain soil 0-6 inches below shot rock fill

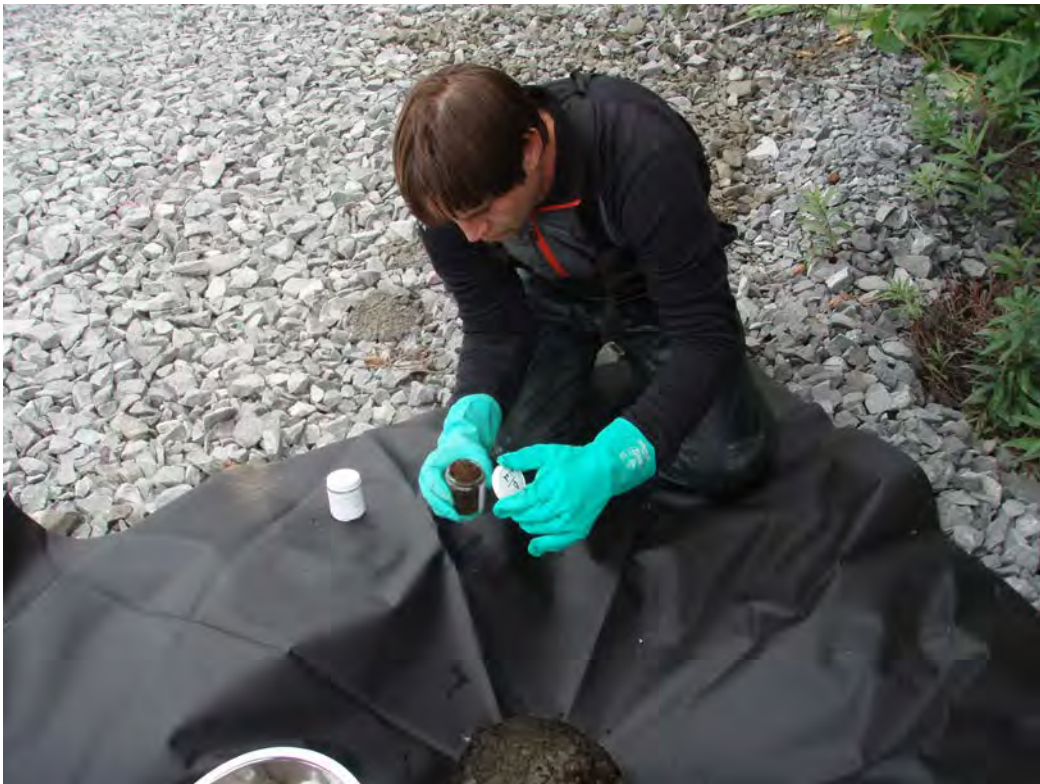
Photo 6: Cap jar over pit to direct spillage

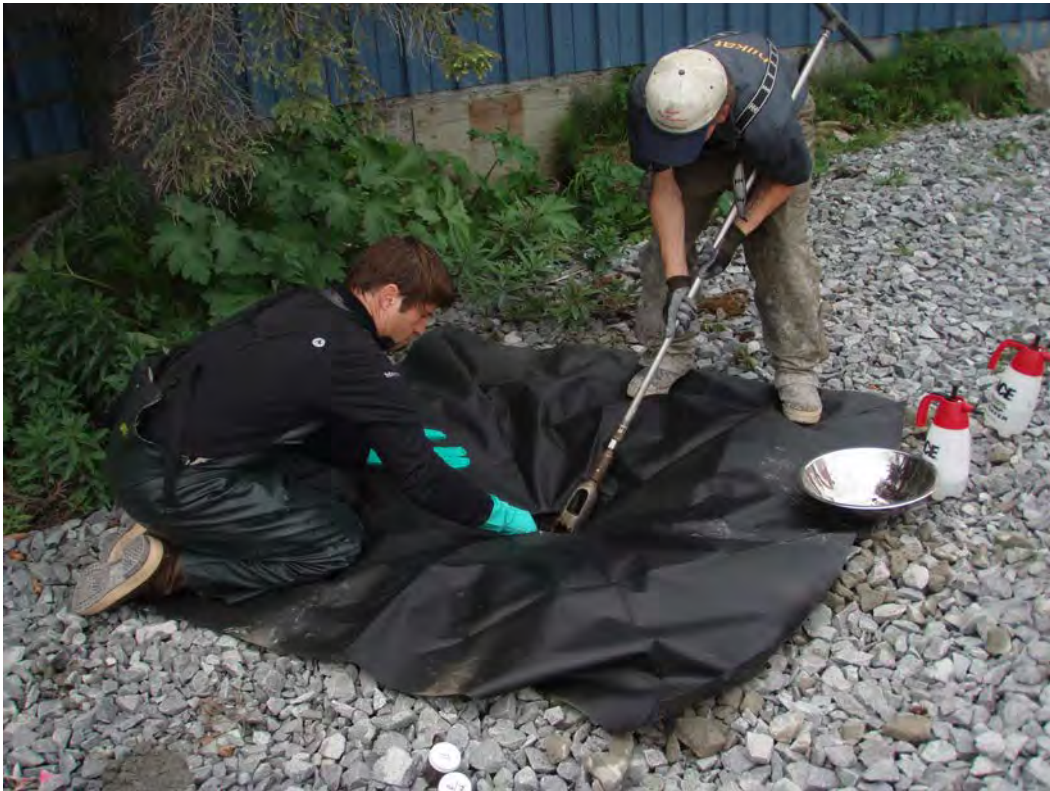
Photo 7: Place fines from bowl into auger pit and use spoon to clean auger of soil

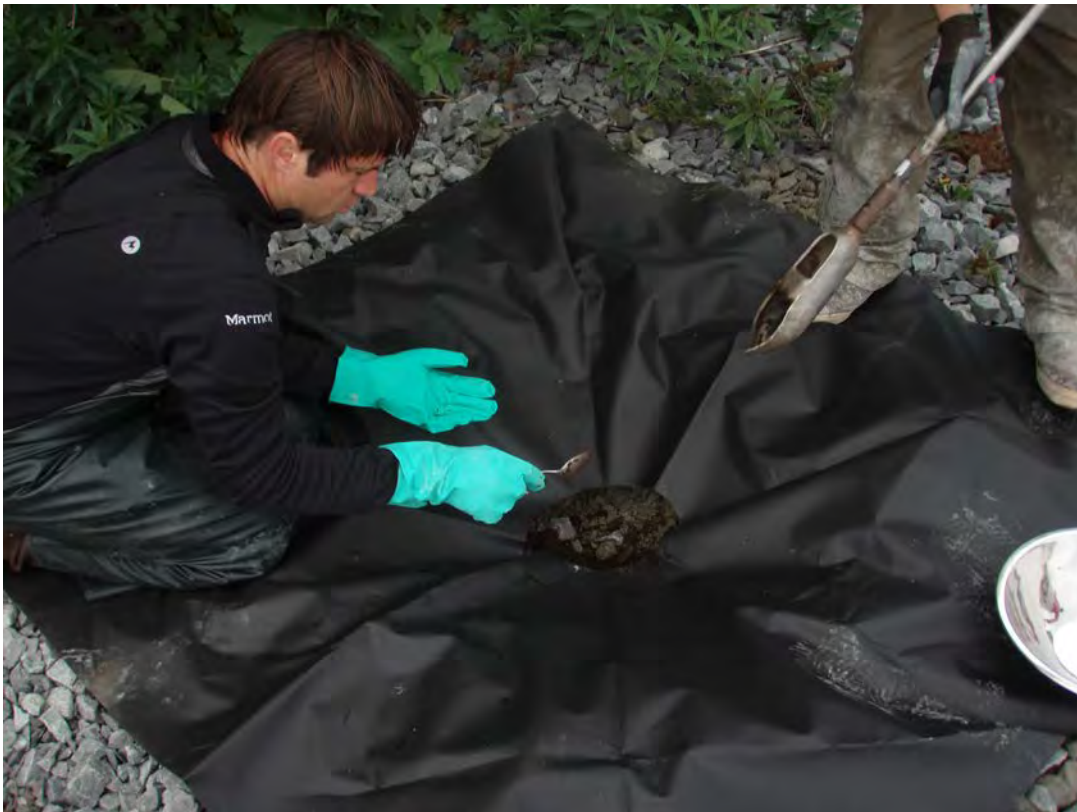
Photo 8: Place fines from bowl into auger pit and use spoon to clean auger of soil

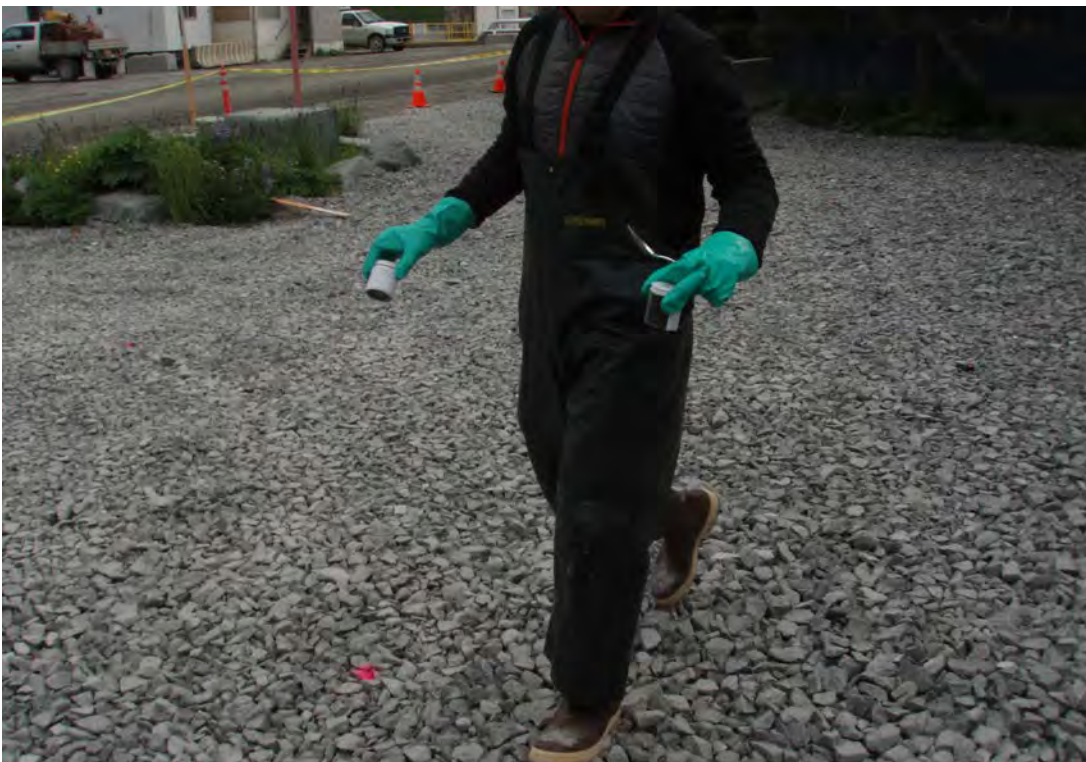
Photo 14: Deliver sample jars to ice chest

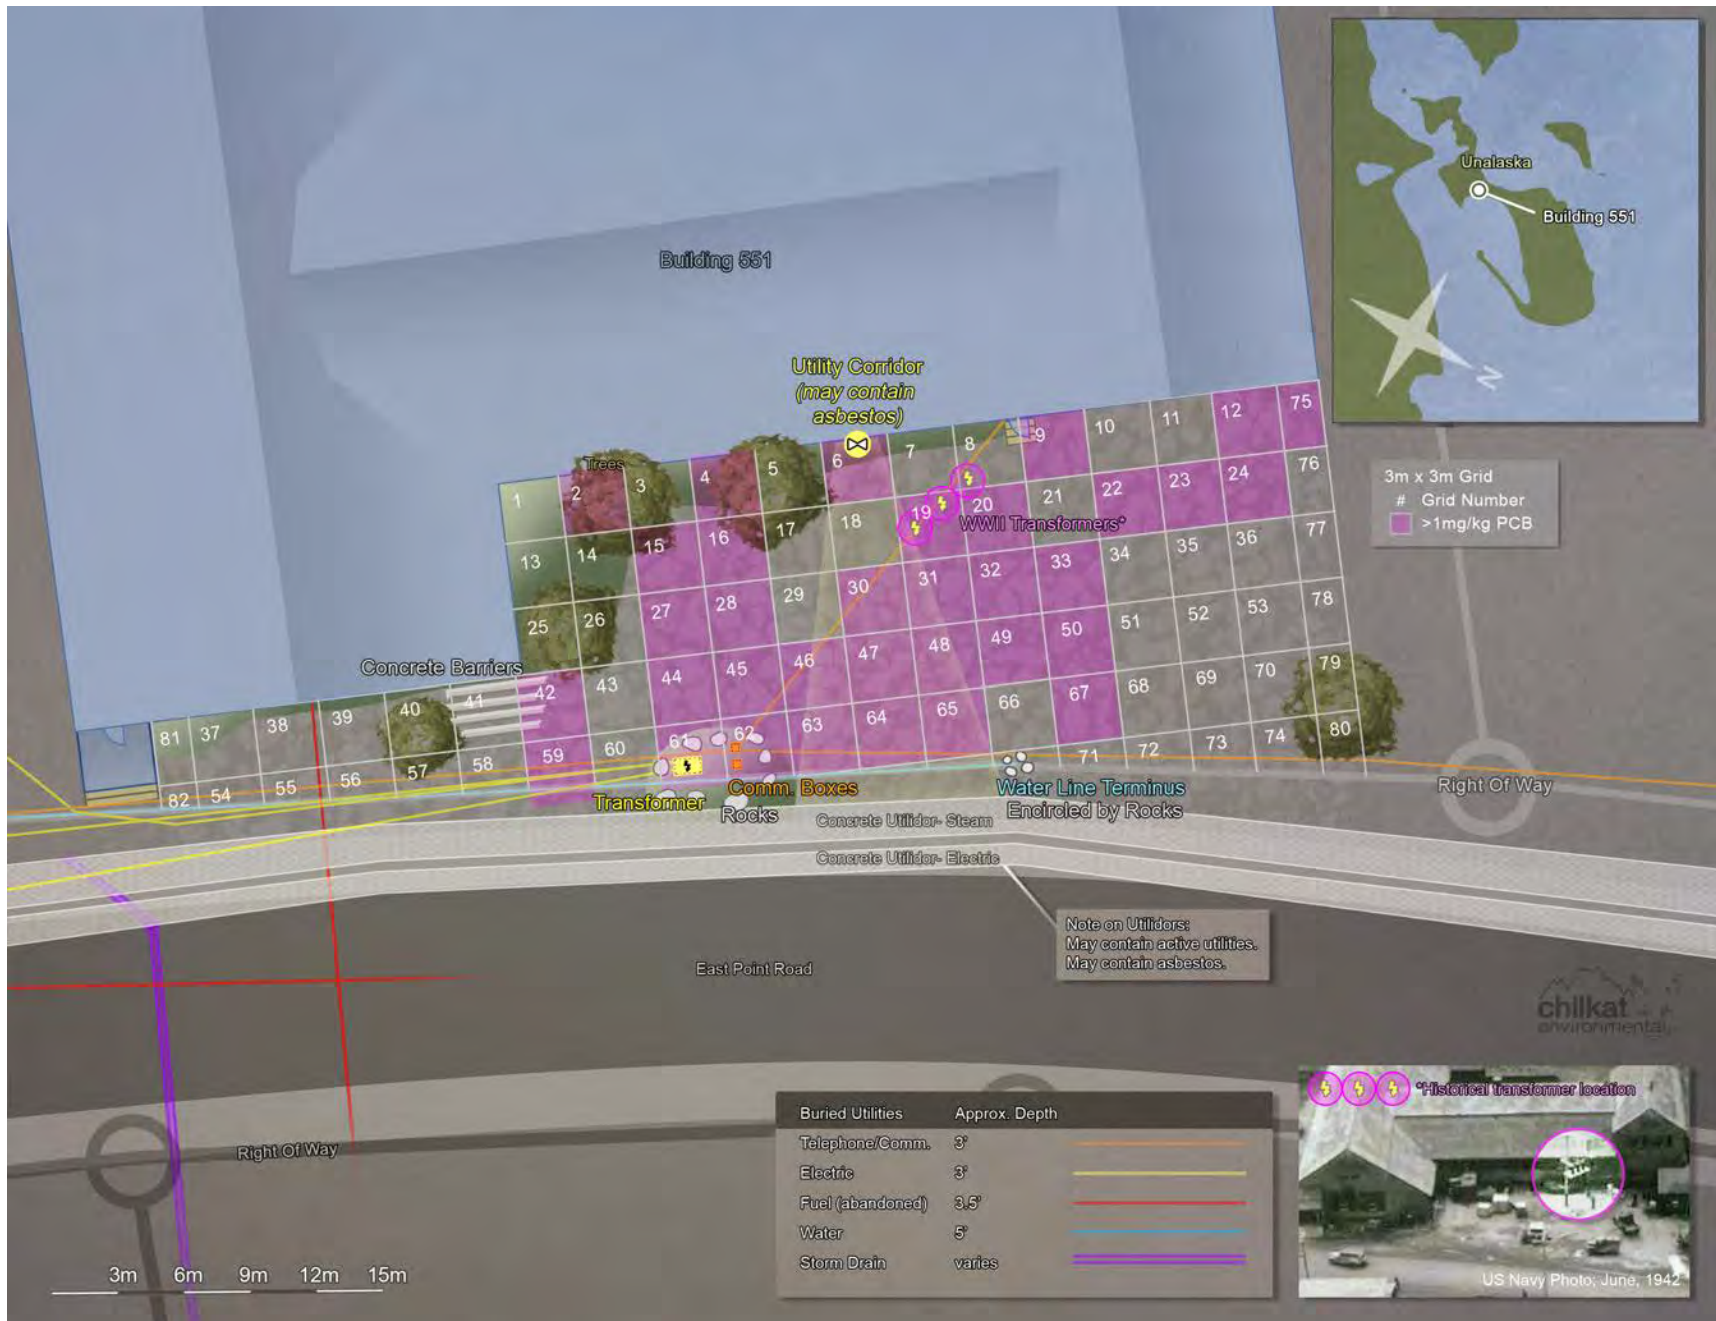
Figure 3: Grid layout with results above 1 mg/kg

Samples were collected July 3-5, 2014, stored on ice, air mailed July 7, and received by the laboratory July 9 at 3 °C. Laboratory Report 407133 and 407134 were received from ADEC approved laboratory Friedman and Bruya Inc. July 24, 2014. Two reports were provided reflecting the contents of the two ice chests. The laboratory reports and data quality review checklists are included as Attachment B. Samples were analyzed by EPA method 8082(a) with results reported by dry-weight as per 40 CFR 761.274. 97. All results were Aroclor 1260 and no other Aroclors were observed. All data is considered usable. Figure 3 provides the final grid layout with categorized results. Figure 4 provides detailed results. Table 3 provides results in spreadsheet format and includes date, time, depth of fill, description of the sample matrix, identification of blind duplicates and identification of deep sample grid locations and soil composition. Table 4 provides this same information for the five subsurface samples.

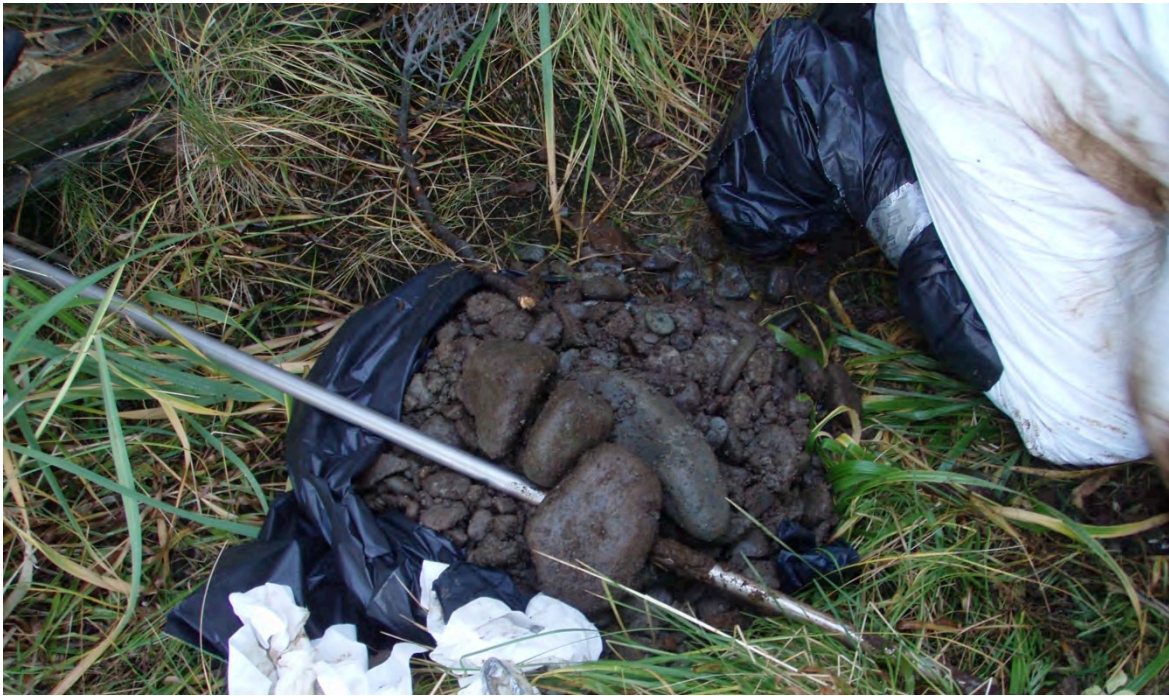
Photo 6: Rocky substrate encountered 1 foot below ground surface beneath fine soil lens
